# RESEARCH & DEVELOPMENT

### **Risk Assessment of Roadside Utility Structures under Vehicular Impacts**

February 29, 2020

1. Report No. <b>NCDOT 2018-24</b>		2. Government Accession No.		3. Recipient's Catalog No.	
4. Title and Subtitle <b><i>Risk Assessment of Roadside Utility Structures under Vehicular Impacts</i></b>				5. Report Date <b>February 29, 2020</b>

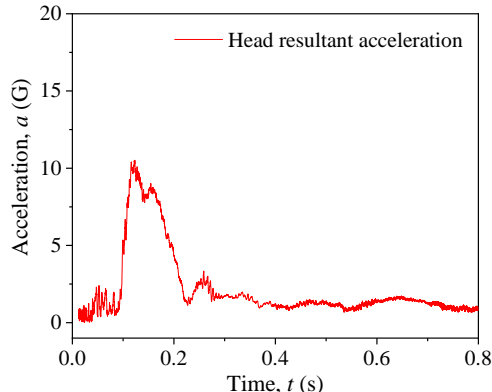
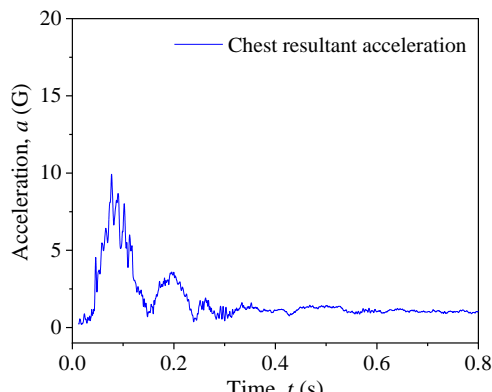
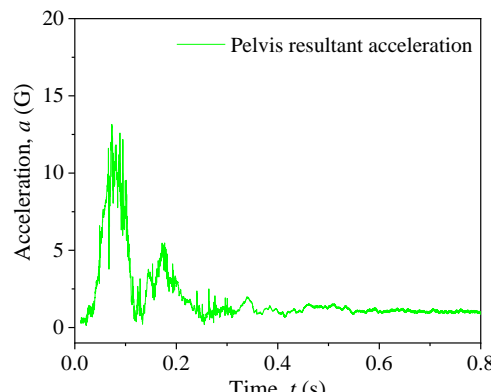
Table 4.42 Dummy responses and injury parameters for Category 3 – Case 5.

Dummy head acceleration	Head impact criteria

Head injury parameter	Value	Threshold	Pass/Fail
	$HIC_{15}$	4.63	700	Pass
	$p(HIC_{15})$	0 %	31%	Pass
Dummy chest acceleration	Dummy pelvis acceleration

The simulation results of Category 3 – Case 5 showed that the mailbox unit impacted first by the vehicle remained attached to the ground. The second mailbox unit was pushed down to the ground with the pedestal attached to the upper body. The damage of the vehicle was on the front bumper and hood. The trajectory of the mailbox showed that there was no possibility of hitting the windshield of vehicle, eliminating the possibility of compartment intrusions. The vehicle's roll and pitch angles, as well as the OIVs and ORAs in both longitudinal and lateral directions, were all within the MASH allowed limits. During impact, the dummy's head moved forward and hit

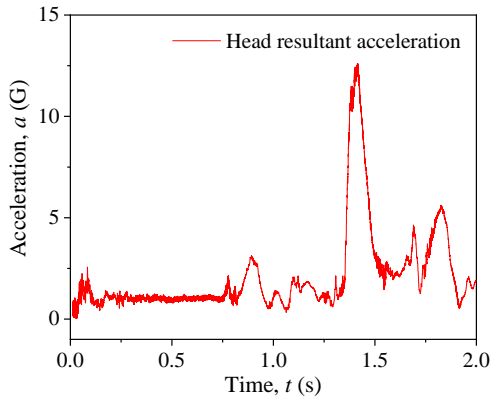
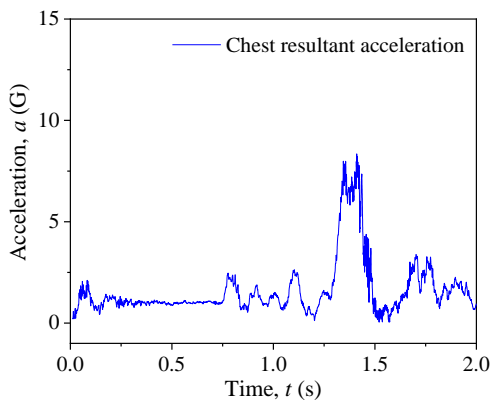
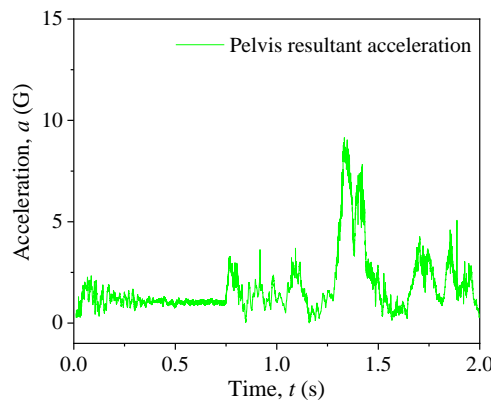
Table 4.46 Dummy responses and injury parameters for Category 3 – Case 7.

Dummy head acceleration		Head impact criteria

Head injury parameter	Value	Threshold	Pass/Fail
	$HIC_{15}$	7.88	700	Pass
	$p(HIC_{15})$	0 %	31%	Pass
Dummy chest acceleration		Dummy pelvis acceleration

The simulation results of Category 3 – Case 7 showed that the upper body of the unit impacted first was separated from the pedestal instantly upon impact, followed by the detachment of the upper body of the second unit from the pedestal. The pedestal of the second mailbox unit, which was still fastened tightly to the ground, stuck on the chassis of the vehicle and caused the vehicle to spin. Consequently, the mailbox units were not pushed further and there was no possibility of penetrating the occupant compartment. The vehicle's roll and pitch angles, as well as the OIVs and ORAs in both longitudinal and lateral directions, were all within the MASH allowed limits. During impact, the dummy's head moved forward and hit the deployed airbag. The maximum head acceleration was approximately 12.5 G and the HIC<sub>15</sub> value was calculated to be 7.88, far below

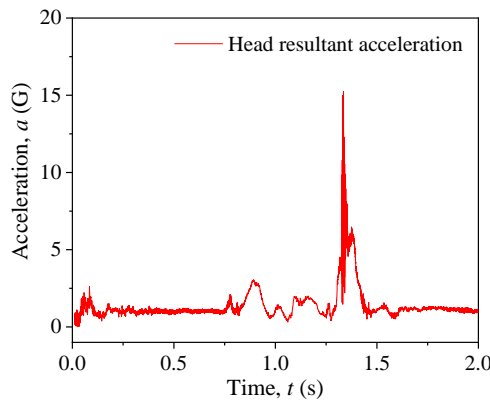
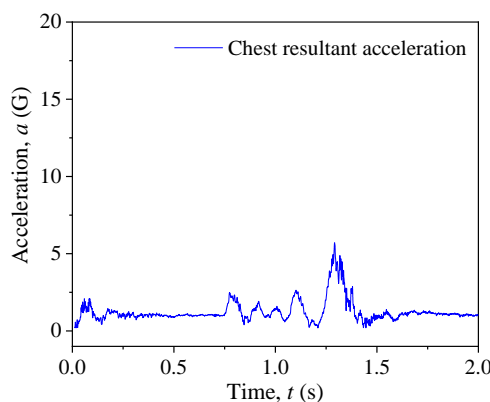
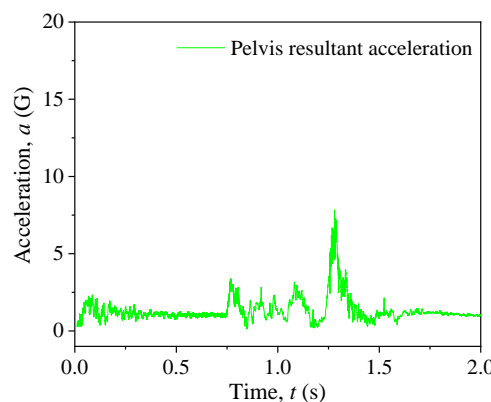
Table 4.48 Dummy responses and injury parameters for Category 3 – Case 8.

Dummy head acceleration		Head impact criteria

Head injury parameter	Value	Threshold	Pass/Fail	
	HIC <sub>15</sub>	2.68	700	Pass	
	$p(\text{HIC}_{15})$	0 %	31%	Pass	
Dummy chest acceleration		Dummy pelvis acceleration

The simulation results of Category 3 – Case 8 showed that the mailbox unit being impacted first was mostly intact, while the second mailbox unit was pushed leaning backwards with no failure on the connections with the pedestal and to the ground. The damage on the vehicle was minimal and localized on the front right corner. The trajectory of the mailbox showed no possibility of hit the windshield of vehicle and thus no possibility of penetrating the occupant compartment. The vehicle's roll and pitch angles, as well as the OIVs and ORAs in both longitudinal and lateral directions, were all within the MASH allowed limits. For occupant response, the dummy's head moved forward and hit the deployed airbag. The maximum head acceleration was approximately 15 G and the HIC<sub>15</sub> value was calculated to be 2.68, far below the threshold value of 700 and indicating no possibility of skull injury. The above analysis indicated that there was no potential

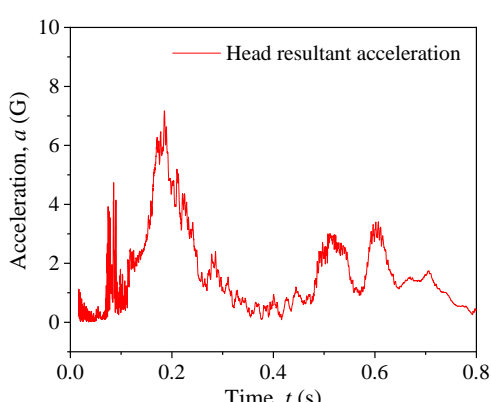
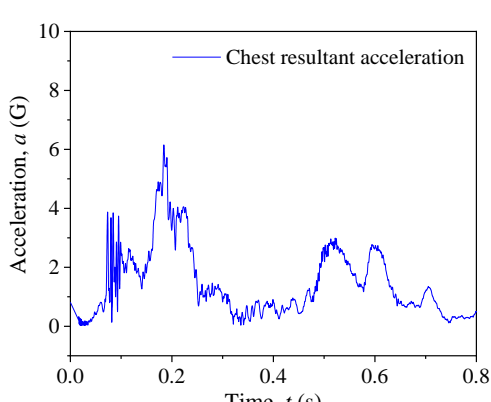
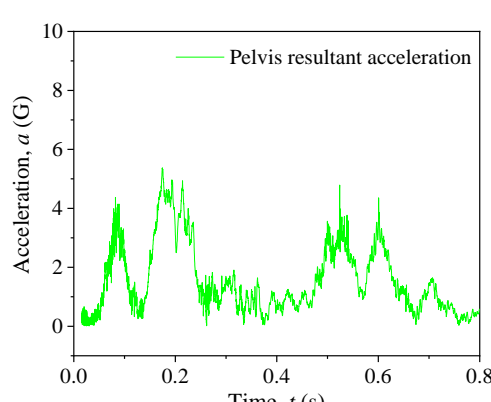
Table 4.50 Dummy responses and injury parameters for Category 4 – Case 1.

Dummy head acceleration		Head impact criteria

Head injury parameter	Value	Threshold	Pass/Fail
		HIC <sub>15</sub>	1.44	700	Pass
		<i>p</i> (HIC <sub>15</sub> )	0 %	31%	Pass
Dummy chest acceleration		Dummy pelvis acceleration

The simulation results of Category 4 – Case 1 showed that the upper unit of the mailbox was detached from the pedestal instantly upon impact and pushed forward by the vehicle in its travel direction. The damage on the vehicle was minimal, a shallow flat dent on the front. The trajectory of the mailbox showed no possibility of hitting the windshield of vehicle and thus no possibility of penetrating the occupant compartment. The vehicle's roll and pitch angles, as well as the OIVs and ORAs in both longitudinal and lateral directions, were all within the MASH allowed limits. During impact, the dummy's head moved forward but did not hit the deployed airbag. The maximum head acceleration was approximately 7 G and the HIC<sub>15</sub> value was calculated to be 1.44, far below the threshold value of 700 and indicating no possibility of skull injury. The above analysis indicated that there was no potential occupant injury for this impact case.

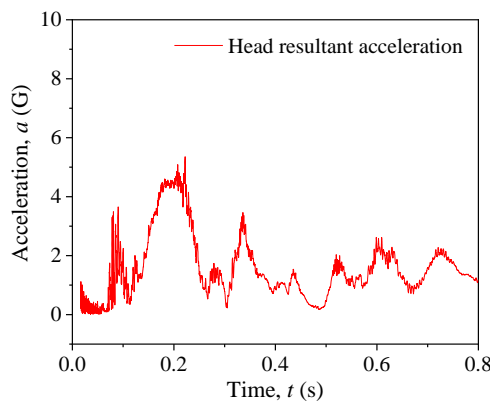
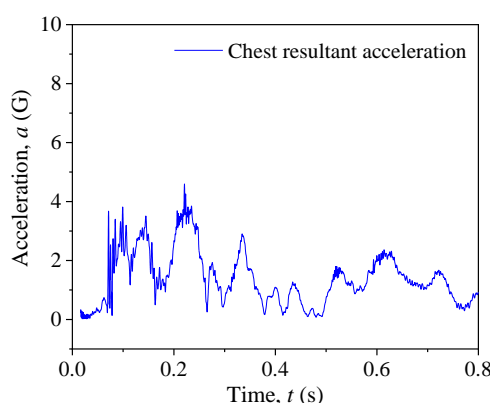
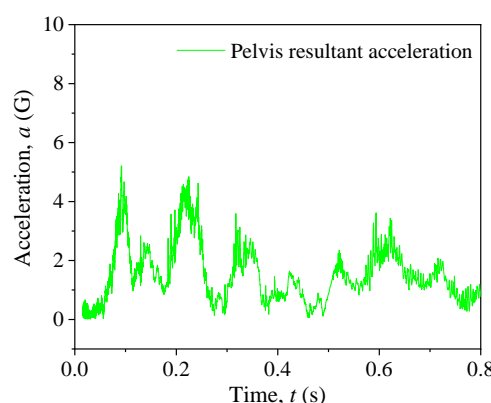
Table 4.52 Dummy responses and injury parameters for Category 4 – Case 2.

Dummy head acceleration	Head impact criteria

Head injury parameter	Value	Threshold	Pass/Fail
	HIC <sub>15</sub>	0.66	700	Pass
	$p(\text{HIC}_{15})$	0 %	31%	Pass
Dummy chest acceleration	Dummy pelvis acceleration

The simulation results of Category 4 – Case 2 showed that the upper body of the mailbox was detached from the pedestal upon impacts and pushed and forward in the vehicle’s travel direction. The mailbox was severely damage but the damage to the vehicle was minimal. The trajectory of the mailbox showed no possibility of hitting the windshield of vehicle and thus no possibility of penetrating the occupant compartment. The vehicle’s roll and pitch angles, as well as the OIVs and ORAs in both longitudinal and lateral directions, were all within the MASH allowed limits. During impact, the dummy’s head moved forward and but did not touch the deployed airbag. The maximum head acceleration was approximately 5 G and the HIC<sub>15</sub> value was calculated to be 0.66, far below the threshold value of 700 and indicating no possibility of skull injury. The above analysis indicated that there was no potential occupant injury for this impact case.

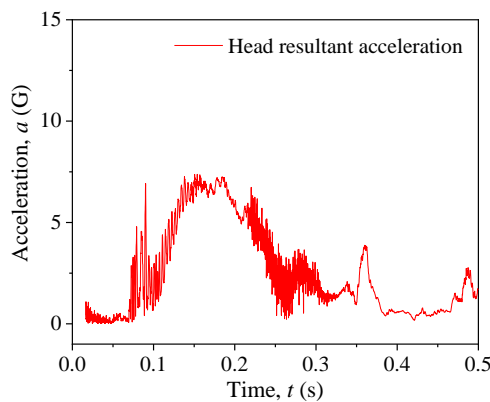
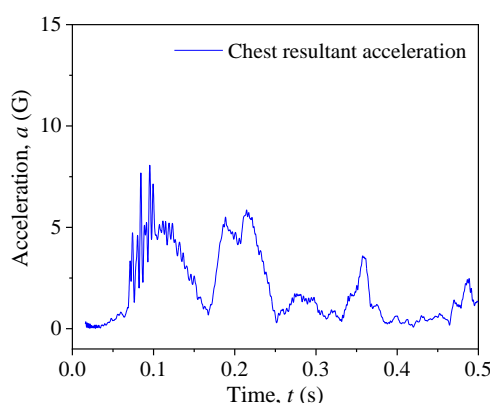
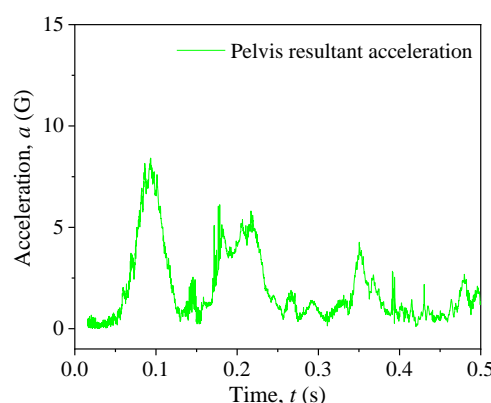
Table 4.54 Dummy responses and injury parameters for Category 4 – Case 3.

Dummy head acceleration		Head impact criteria

Head injury parameter	Value	Threshold	Pass/Fail	
	HIC <sub>15</sub>	1.95	700	Pass	
	$p(\text{HIC}_{15})$	0 %	31%	Pass	
Dummy chest acceleration		Dummy pelvis acceleration

The simulation results of Category 4 – Case 3 showed that both pedestals were detached from the upper bodies upon impact and were pushed forward in the vehicle’s travel direction, with the unit impacted first having larger damage than the second unit. The damage on the vehicle was shown as a shallow dent on the front. The trajectory of the mailbox showed no possibility of hitting the windshield of vehicle and thus no possibility of penetrating the occupant compartment. The vehicle’s roll and pitch angles, as well as the OIVs and ORAs in both longitudinal and lateral directions, were all within the MASH allowed limits. During impact, the dummy’s head moved forward and hit the deployed airbag. The maximum head acceleration was approximately 7 G and the HIC<sub>15</sub> value was calculated to be 1.95, far below the threshold value of 700 and indicating no possibility of skull injury. The above analysis indicated that there was no potential occupant injury for this impact case.

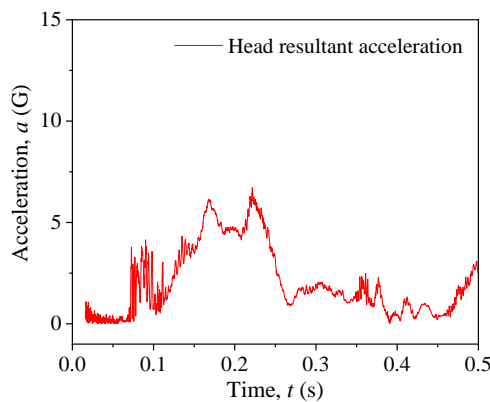
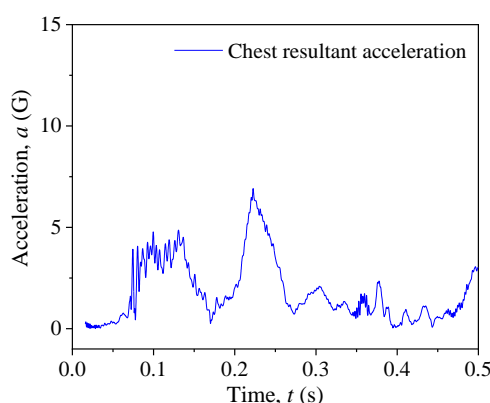
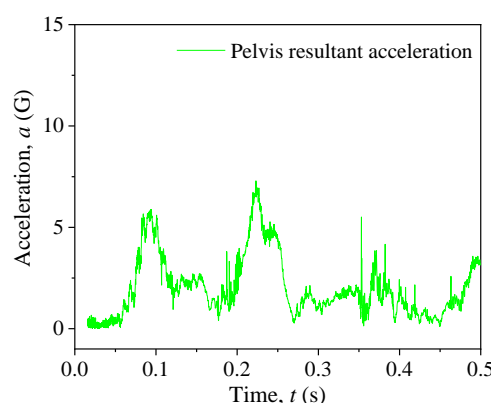
Table 4.56 Dummy responses and injury parameters for Category 4 – Case 4.

Dummy head acceleration	Head impact criteria

Head injury parameter	Value	Threshold	Pass/Fail
	HIC <sub>15</sub>	1.27	700	Pass
	$p(\text{HIC}_{15})$	0 %	31%	Pass
Dummy chest acceleration	Dummy pelvis acceleration

The simulation results of Category 4 – Case 4 showed that the upper body of the mailbox unit impacted first was detached from the pedestal upon impact and was severely crushed by the vehicle before the upper body of the second unit was knocked off the pedestal. The upper body of the first unit was pushed forward in the vehicle’s travel direction and the upper body of the second unit was pushed to the drive side of the vehicle due to rotation. The damage on the vehicle was a shallow V-shape dent on the front. The trajectory of the mailbox showed no possibility of hitting the windshield of vehicle and thus no possibility of penetrating the occupant compartment. The vehicle’s roll and pitch angles, as well as the OIVs and ORAs in both longitudinal and lateral directions, were all within the MASH allowed limits. During impact, the dummy’s head moved forward but did not touch the deployed airbag. The maximum head acceleration was approximately 6 G and the HIC<sub>15</sub> value was calculated to be 1.27, far below the threshold value of 700 and indicating no possibility of skull injury. The above analysis indicated that there was no potential occupant injury for this impact case.

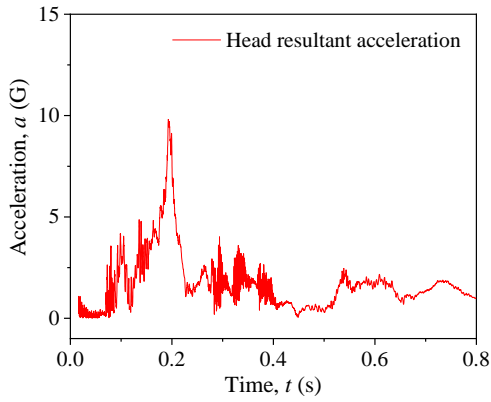
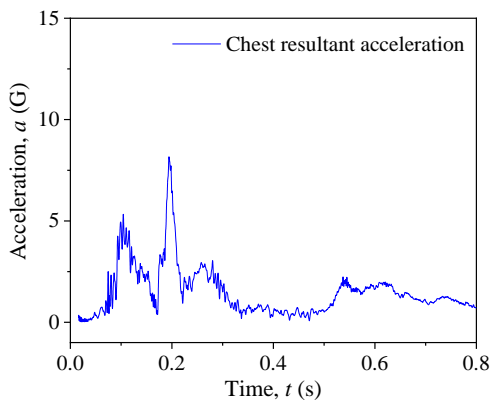
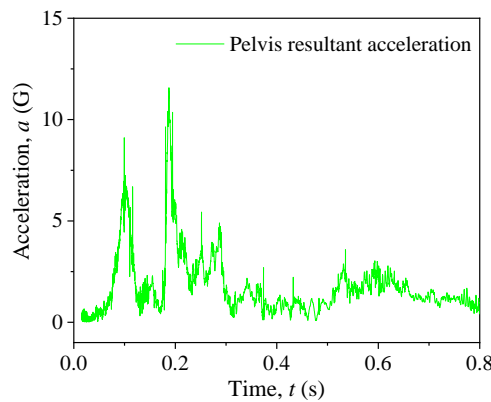
Table 4.58 Dummy responses and injury parameters for Category 4 – Case 5.

Dummy head acceleration		Head impact criteria

Head injury parameter	Value	Threshold	Pass/Fail
		$HIC_{15}$	2.89	700	Pass
		$p(HIC_{15})$	0 %	31%	Pass
Dummy chest acceleration		Dummy pelvis acceleration

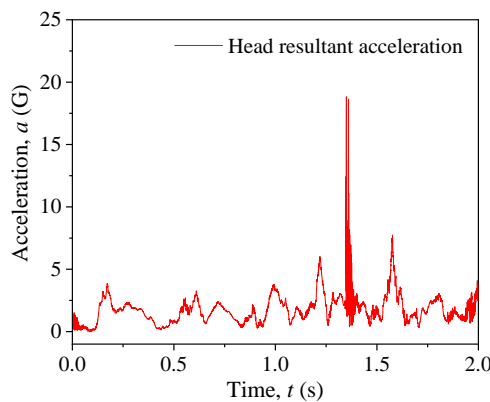
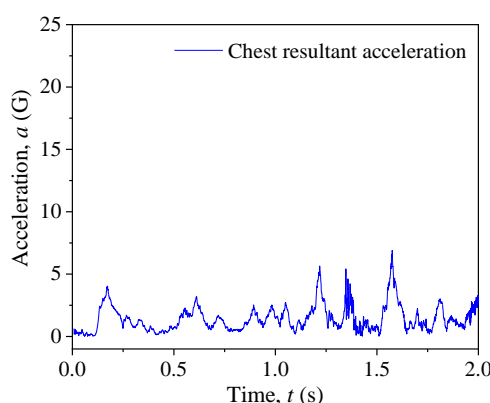
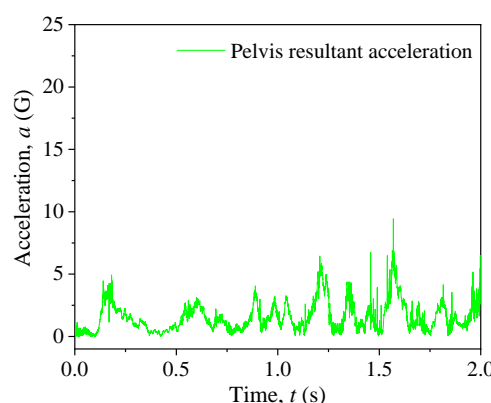
Table 4.60 Dummy responses and injury parameters for Category 4 – Case 6.

Dummy head acceleration		Head impact criteria

Head injury parameter	Value	Threshold	Pass/Fail	
	HIC <sub>15</sub>	1.53	700	Pass	
	$p(\text{HIC}_{15})$	0 %	31%	Pass	
Dummy chest acceleration		Dummy pelvis acceleration

The simulation results of Category 4 – Case 6 showed that the upper body of the mailbox was detached from the pedestal upon impact and was pushed forward in the vehicle's travel direction. There was no visible damage on the vehicle and there was no possibility for the mailbox to penetrate the occupant compartment. The vehicle's roll and pitch angles, as well as the OIVs and ORAs in both longitudinal and lateral directions, were all within the MASH allowed limits. During impact, the dummy's head moved forward but did not touch the deployed airbag. The HIC<sub>15</sub> value was calculated to be 1.53, which was far below the threshold value of 700 and indicating no possibility of skull injury. The above analysis indicated that there was no potential occupant injury for this impact case.

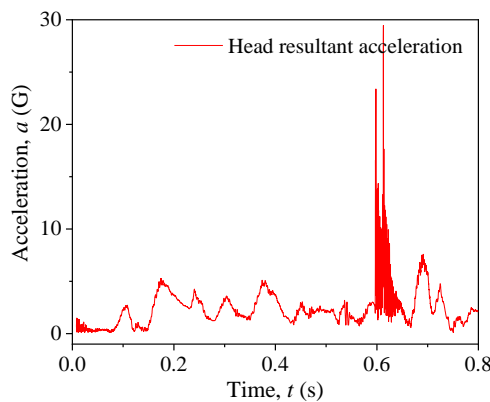
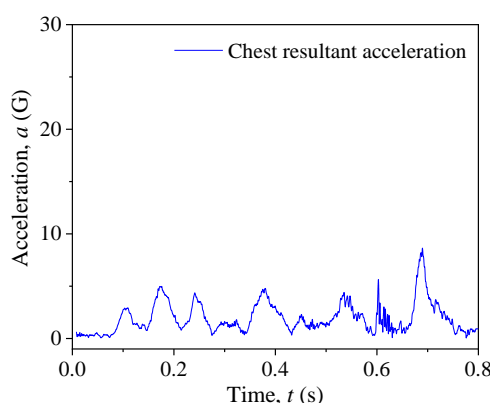
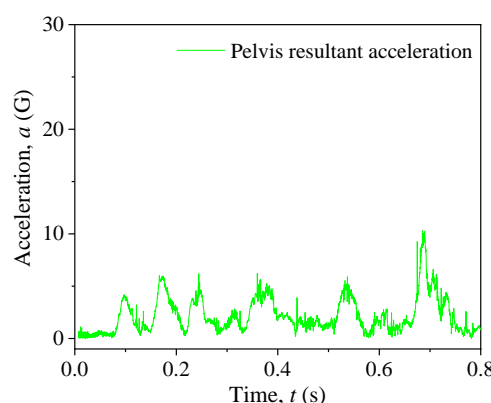
Table 4.62 Dummy responses and injury parameters for Category 4 – Case 7.

Dummy head acceleration	Head impact criteria

Head injury parameter	Value	Threshold	Pass/Fail
	HIC <sub>15</sub>	2.51	700	Pass
	$p(\text{HIC}_{15})$	0 %	31%	Pass
Dummy chest acceleration	Dummy pelvis acceleration

The simulation results of Category 4 – Case 7 showed that the upper bodies of both mailbox units were detached from the pedestals upon impacts and pushed forward in the vehicle's travel direction. The pedestals were then stuck under the vehicle's chassis and were detached from the ground bases. The damage to the vehicle was minimal and there was no possibility for the mailbox units to penetrate the occupant compartment. The vehicle's roll and pitch angles, as well as the OIVs and ORAs in both longitudinal and lateral directions, were all within the MASH allowed limits. During impact, the dummy's head moved forward but did not touch the deployed airbag. The HIC<sub>15</sub> value was calculated to be 2.51, far below the threshold value of 700 and indicating no possibility of skull injury. The above analysis indicated that there was no potential occupant injury

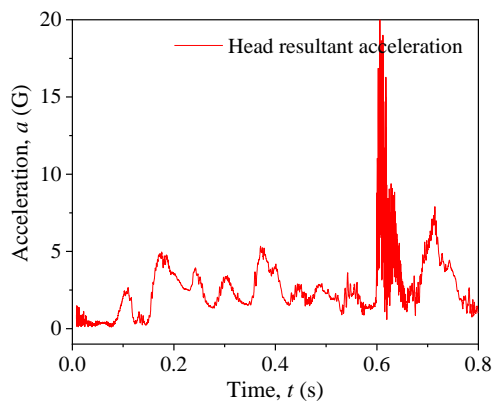
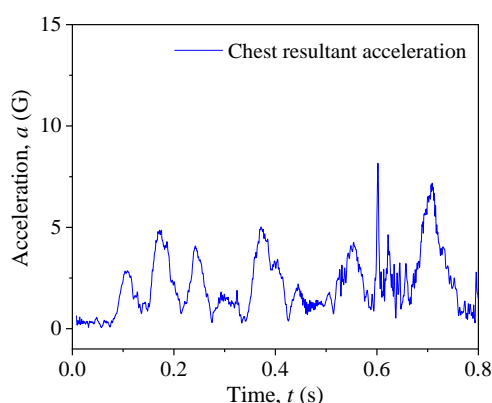
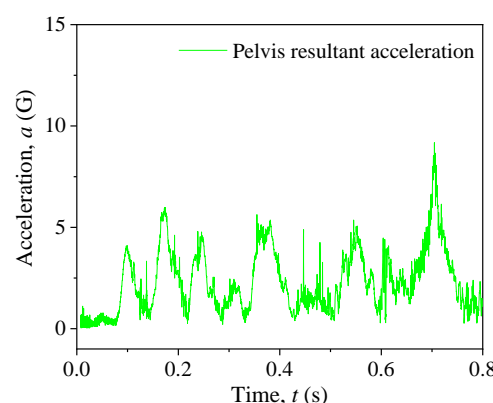
Table 4.64 Dummy responses and injury parameters for Category 4 – Case 8.

Dummy head acceleration	Head impact criteria

Head injury parameter	Value	Threshold	Pass/Fail
	HIC <sub>15</sub>	5.04	700	Pass
	$p(\text{HIC}_{15})$	0 %	31%	Pass
Dummy chest acceleration	Dummy pelvis acceleration

The simulation results of Category 4 – Case 8 showed that the mailbox unit impacted first was twisted due to slight contact with the vehicle and remained attached to the ground. The upper body of the second mailbox unit was detached from the pedestal and pushed forward in the vehicle's travel direction. The damage on the vehicle was minimal and localized on the front right corner. The trajectory of the mailbox showed that there was no possibility for it to hit the windshield of vehicle, eliminating the possibility of compartment intrusions. The vehicle's roll and pitch angles, as well as the OIVs and ORAs in both longitudinal and lateral directions, were all within the MASH allowed limits. During impact, the dummy's head moved forward and hit the deployed airbag. The HIC<sub>15</sub> value was calculated to be 5.04, far below the threshold value of 700 and

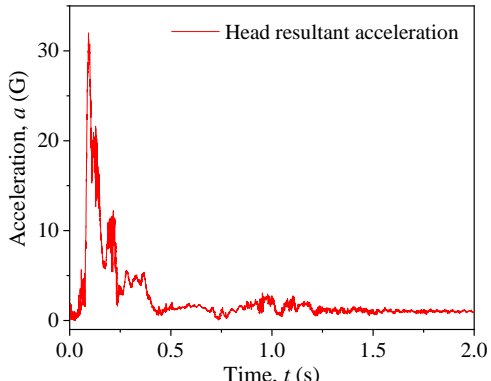
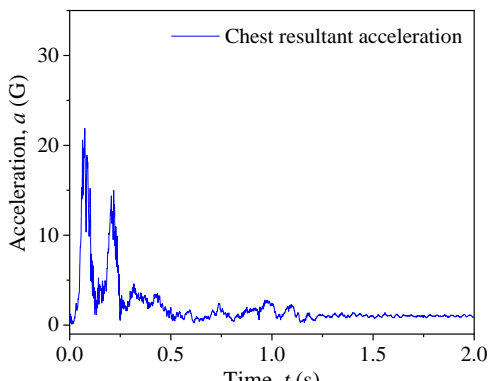
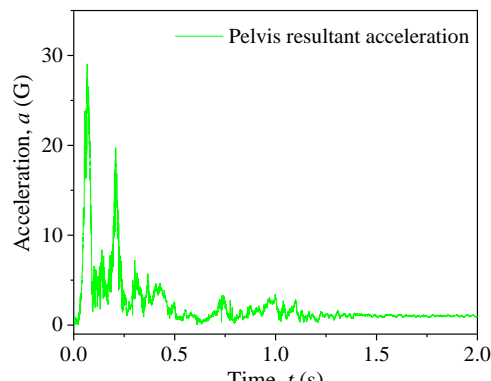
Table 5.2 Dummy responses and injury parameters for Case 1.

Dummy head acceleration	Head impact criteria

Head injury parameter	Value	Threshold	Pass/Fail
	HIC <sub>15</sub>	67.33	700	Pass
	$p(\text{HIC}_{15})$	0.06%	31%	Pass
Dummy chest acceleration	Dummy pelvis acceleration

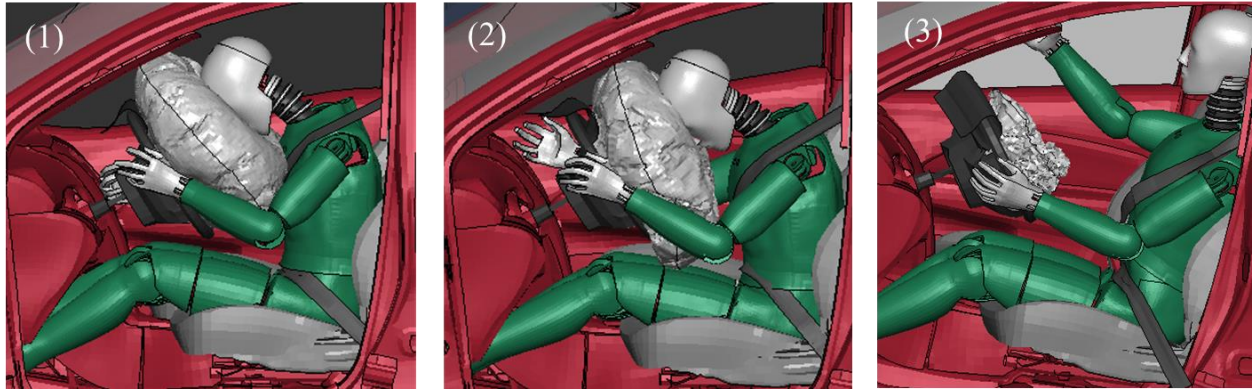
For occupant response, the head acceleration of the crash test dummy was relatively high upon impacting the side columns of the bus shelter. Figure 5.4 shows the crash test dummy responses during the impact of Case 1. It can be seen that the dummy's head bent forward and fully contacted the deployed airbag. The peak head acceleration was approximately 32 G and the HIC<sub>15</sub> value was calculated to be 67.33, which was below the threshold value of 700 and indicated no possibility of skull injury. These results indicated no potential occupant injury for this impact case.

Figure 5.4 Crash test dummy response for Case 1.

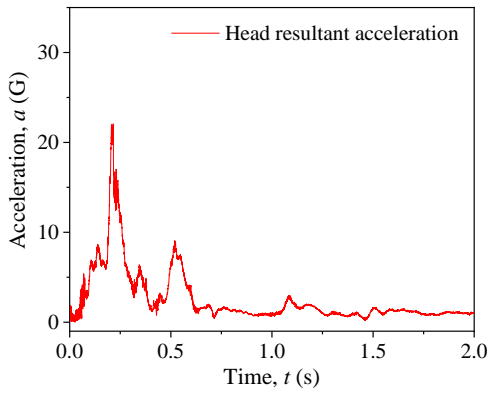
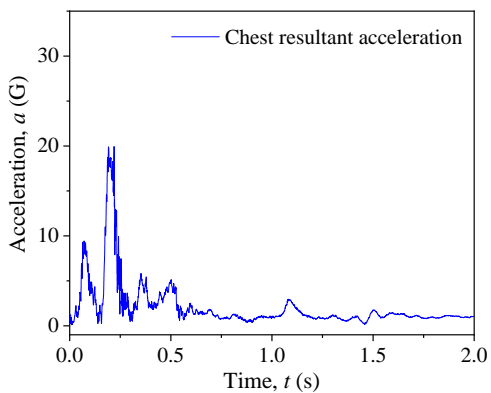
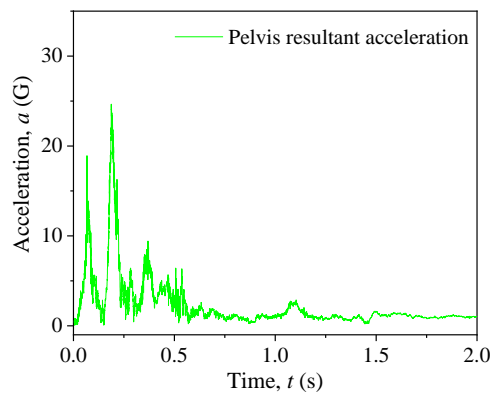
Table 5.4 Dummy responses and injury parameters for Case 2.

Dummy head acceleration		Head impact criteria

Head injury parameter	Value	Threshold	Pass/Fail
		HIC <sub>15</sub>	28.26	700	Pass
		$p(\text{HIC}_{15})$	0 %	31%	Pass
Dummy chest acceleration		Dummy pelvis acceleration

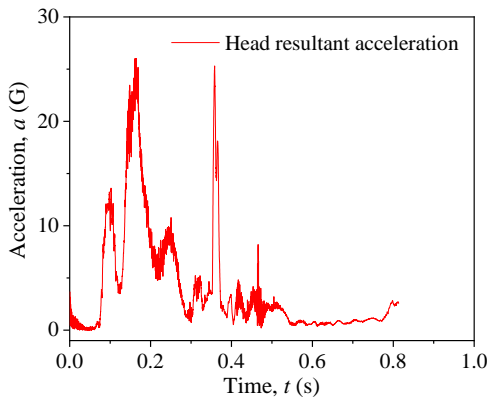
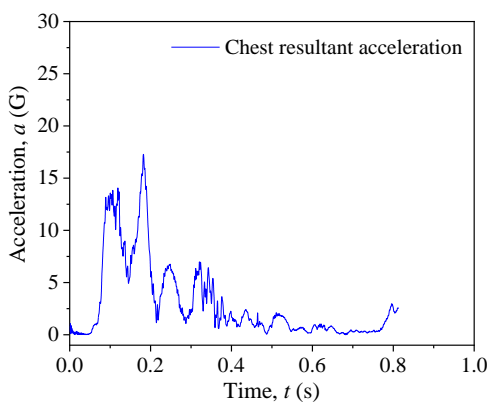
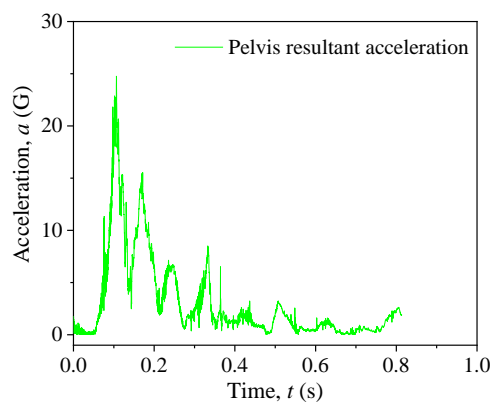
Table 5.6 Dummy responses and injury parameters for Case 3.

Dummy head acceleration	Head impact criteria

Head injury parameter	Value	Threshold	Pass/Fail
	HIC <sub>15</sub>	38.67	700	Pass
	$p(\text{HIC}_{15})$	0%	31%	Pass
Dummy chest acceleration	Dummy pelvis acceleration

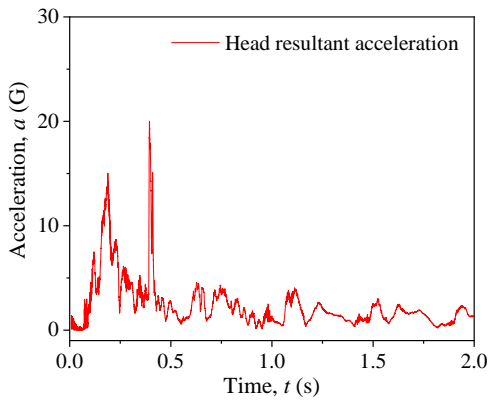
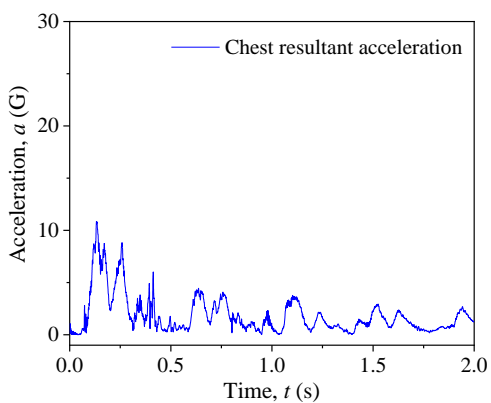
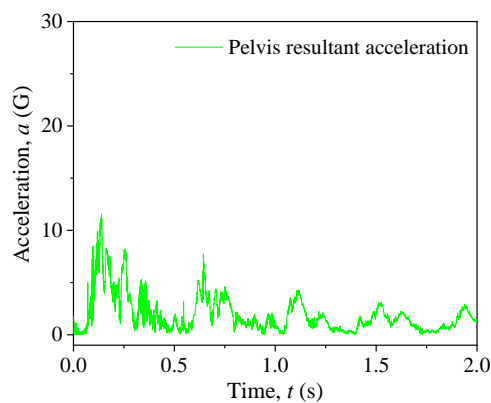
Table 5.8 Dummy responses and injury parameters for Case 4.

Dummy head acceleration	Head impact criteria

Head injury parameter	Value	Threshold	Pass/Fail
	$HIC_{15}$	11.93	700	Pass
	$p(HIC_{15})$	0 %	31%	Pass
Dummy chest acceleration	Dummy pelvis acceleration
